FIRE RISK ASSESSMENT

Denning Point

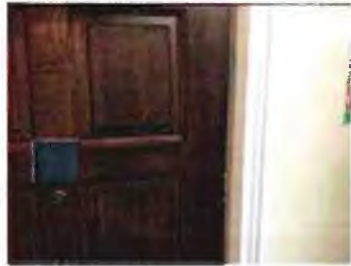
| Item number | Floor | Remedial Works | Actions | Priority /tested and satisfactory/ not applicable | Housing Centre | Asset Management | Regeneration | Date Rectified |
|---|---|---|--|---|---|---|---|---|
| 1 | G-20 | <p>The flat entrance door to property ■ was inspected during the assessment and the following observation noted:</p> <p>It is a compliant fire door but is not fitted with a self-closer, intumescent strips and smoke seals. See photograph below.</p> <p>(DOOR INSPECTED)</p> | <p>During the next maintenance works at the property, consideration should be given to adding a self-closer, intumescent strips and smoke seals to the front entrance door to property ■ to ensure its compliance with British Standard 476.</p> | 4 | X | | | |

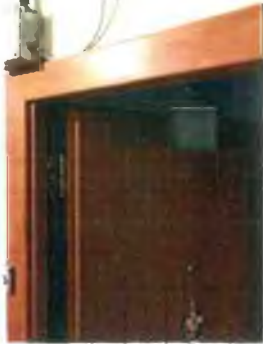
| Item number | Floor | Remedial Works | Actions | Priority /tested and satisfactory/ not applicable | Housing Centre | Asset Management | Regeneration | Date Rectified |
|---|---|---|--|---|---|---|---|---|
| 2 | G-20 | <p>The flat entrance door to property ■ was inspected during the assessment and the following observation noted:</p> <p>It is a compliant fire door and is fitted with a self-closing device, intumescent strip and cold smoke seal. See photograph below.</p> | <p>No action required.</p> | | | | | |

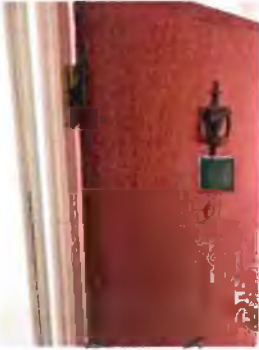
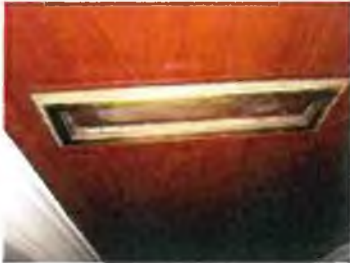
| 3 | G-20 | <p>The flat entrance door to property ■ was inspected during the assessment and the following observation noted:</p> <p>It is a compliant fire door but is not fitted with a self-closer, intumescent strips and smoke seals. It also has a damaged letterbox. See photographs below.</p> | <p>During the next maintenance works at the property, consideration should be given to adding a self-closer, intumescent strips and smoke seals to the front entrance door to property ■ to ensure its compliance with British Standard 476.</p> <p>The letterbox should be repaired .</p> | 4 | X | | | |

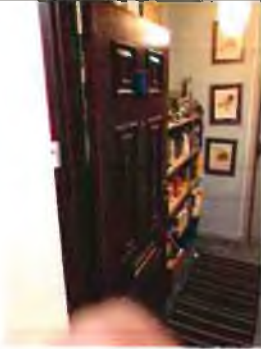
| 4 | G-20 | <p><i>(DOOR INSPECTED)</i></p> <p>The flat entrance door to property ■ was inspected during the assessment and the following observation noted:</p> <p>It is a compliant fire door but is not fitted with a self-closer, intumescent strips and smoke seals. See photograph below.</p> | <p>During the next maintenance works at the property, consideration should be given to adding a self-closer, intumescent strips and smoke seals to the front entrance door to property ■ to ensure its compliance with British Standard 476.</p> | 4 | X | | | |

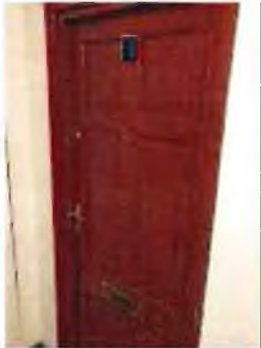
| 6 | G-20 | <p>The flat entrance door to property ■ does not appear to be fire resisting, see photograph below:</p> | <p>During the next maintenance works at the property, consideration should be given to replacing the entrance door to property ■ to ensure its compliance with British Standard 476.</p> <p>(It should be confirmed as non-fire resisting once opened and inspected).</p> | 4 | X | | | |

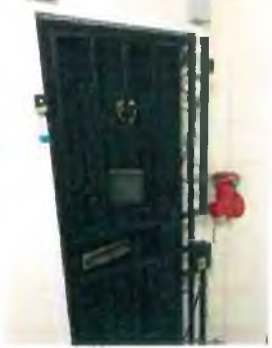
| 7 | G-20 | <p>The flat entrance door to property ■ does not appear to be fire resisting, see photograph below:</p> | <p>During the next maintenance works at the property, consideration should be given to replacing the entrance door to property ■ to ensure its compliance with British Standard 476.</p> <p>(It should be confirmed as</p> | 4 | X | | | |

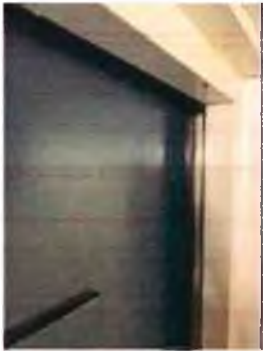
| 41 | 6 | <p>The lobby fire door on the 6th floor (staircase to lobby) is not shutting tightly into its frame, see photograph below.</p> | <p>This fire door should be repaired so that it shuts tightly into its frame.</p> | 3 | X | | | |

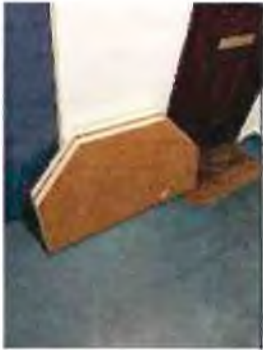
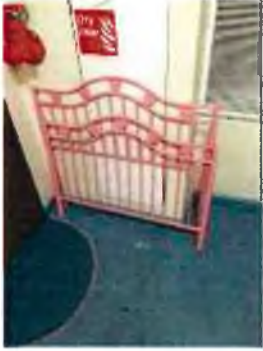
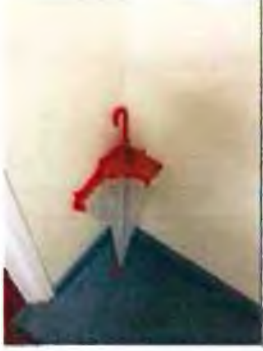
| 42 | G-20 | <p>There are obstructions on the 1st, 9th, 10th and 18th floors. See photographs below.</p> | <p>Residents should be advised to keep the common areas, staircases and areas outside their flats clear, sterile and unobstructed at all times. These fire escape routes must be protected at all times. This also includes around the perimeter of the building to reduce the chances of an arson attack.</p> | 1 | X | | | |
