# **FIRE RISK ASSESSMENT**

## Shearsmith House

<b>Premises Address:</b> <i>Shearsmith House Hindmarsh Close London, E1 8HT</i>	<b>Use of Premises:</b> <i>Residential block.</i>
<b>Date of Risk Assessment:</b> <i>23 February 2017</i>	<b>Date of Review:</b> <i>23 February 2018</i>

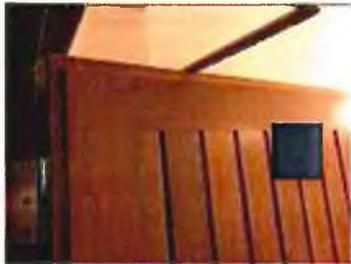
Priority/tested and satisfactory/not applicable	Housing Centre	Asset Management	Regeneration	Date Rectified
Item number	Floor	Remedial Works	Actions					
1	G-27	<p>The flat entrance door to property ■ was inspected during the assessment and the following observation noted:</p> <p>It is a compliant fire door and is fitted with a self-closing device, intumescent strip and cold smoke seal. See photograph below.</p>

<p>(DOOR INSPECTED)</p>	<b>No action required.</b>					
2	G-27	<p>The flat entrance door to property ■ was inspected during the assessment and the following observation noted:</p> <p>It is a compliant fire door and is fitted with a self-closing device, intumescent strip and cold smoke seal. See photograph below.</p>	<b>No action required.</b>

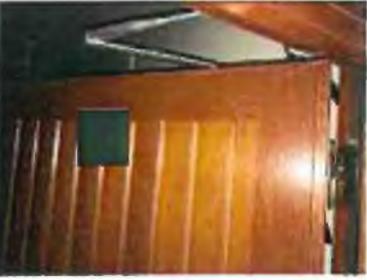
(DOOR INSPECTED)							
3	G-27	<p>The flat entrance door to property ■ was inspected during the assessment and the following observation noted:</p> <p>It is a compliant fire door and is fitted with a self-closing device, intumescent strip and cold smoke seal. See photograph below.</p>

No action required.						
		(DOOR INSPECTED)							
4	G-27	<p>The flat entrance door to property ■ was inspected during the assessment and the following observation noted:</p> <p>It is a compliant fire door but is not fitted with a self-closer, intumescent strips and smoke seals. See photograph below.</p>

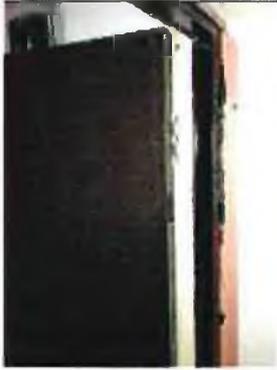
<p>fitted with a self-closer but no intumescent strips and smoke seals. See photograph below.</p>

<p>property ■ to ensure its compliance with British Standard 476.</p>					
		<p>(DOOR INSPECTED)</p>						
6	G-27	<p>The flat entrance door to property ■ does not appear to be fire resisting, see photograph below:</p>

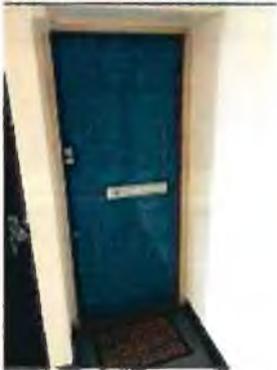
<p>During the next maintenance works at the property, consideration should be given to replacing the entrance door to property ■ to ensure its compliance with British Standard 476.</p> <p>(It should be confirmed as non-fire resisting once opened and inspected).</p>	4	X			
7	G-27	<p>The flat entrance door to property ■ does not appear to be fire resisting, see photograph below:</p>

<p>During the next maintenance works at the property, consideration should be given to replacing the entrance door to property ■ to ensure its compliance with British Standard 476.</p> <p>(It should be confirmed as non-fire resisting once opened and inspected).</p>	4	X

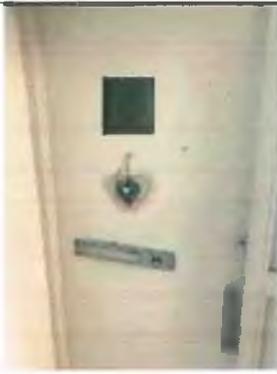
8	G-27	<p>The flat entrance door to property ■ does not appear to be fire resisting, see photograph below:</p>	<p>During the next maintenance works at the property, consideration should be given to replacing the entrance door to property ■ to ensure its compliance with British Standard 476.</p>	4	X

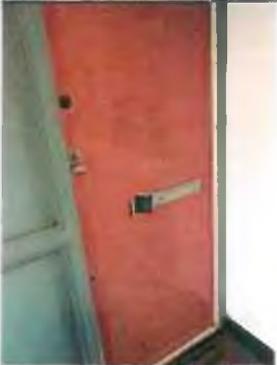
<i>(It should be confirmed as non-fire resisting once opened and inspected).</i>					
9	G-27	<p>The flat entrance door to property ■ does not appear to be fire resisting, see photograph below:</p>

<p>During the next maintenance works at the property, consideration should be given to replacing the entrance door to property ■ to ensure its compliance with British Standard 476.</p> <p><i>(It should be confirmed as non-fire resisting once opened and inspected).</i></p>	4	X			
10	G-27	<p>The flat entrance door to property ■ does not appear to be fire resisting, see photograph below:</p>

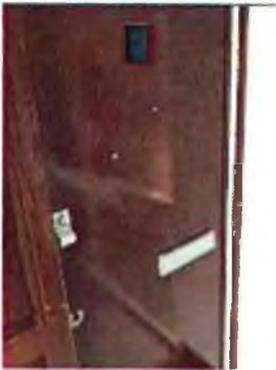
12	G-27	<p>The flat entrance door to property ■ does not appear to be fire resisting, see photograph below:</p>

<p>During the next maintenance works at the property, consideration should be given to replacing the entrance door to property ■ to ensure its compliance with British Standard 476.</p> <p>(It should be confirmed as non-fire resisting once opened and inspected).</p>	4	X			
13	G-27	<p>The flat entrance door to property ■ does not appear to be fire resisting, see photograph below:</p>

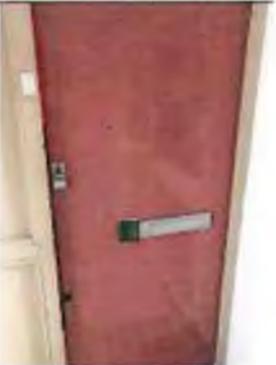
15	G-27	<p>The flat entrance door to property ■ does not appear to be fire resisting, see photograph below:</p>

<p>During the next maintenance works at the property, consideration should be given to replacing the entrance door to property ■ to ensure its compliance with British Standard 476.</p> <p>(It should be confirmed as non-fire resisting once opened and inspected).</p>	4	X				
16	G-27	<p>The flat entrance door to property ■ does not appear to be fire resisting, see photograph below:</p>

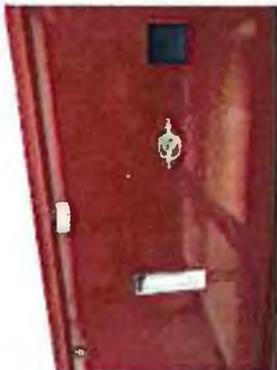
18	G-27	<p>The flat entrance door to property ■ does not appear to be fire resisting, see photograph below:</p>

<p>During the next maintenance works at the property, consideration should be given to replacing the entrance door to property ■ to ensure its compliance with British Standard 476.</p> <p>(It should be confirmed as non-fire resisting once opened and inspected).</p>	4	X			
19	G-27	<p>The flat entrance door to property ■ does not appear to be fire resisting, see photograph below:</p>

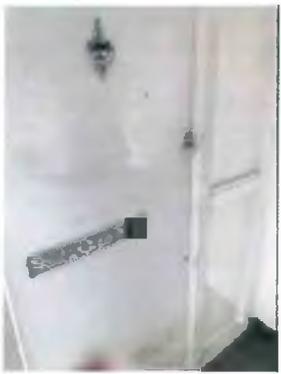
21	G-27	<p>The flat entrance door to property ■ does not appear to be fire resisting, see photograph below:</p>

<p>During the next maintenance works at the property, consideration should be given to replacing the entrance door to property ■ to ensure its compliance with British Standard 476.</p> <p>(It should be confirmed as non-fire resisting once opened and inspected).</p>	4	X				
22	G-27	<p>The flat entrance door to property ■ does not appear to be fire resisting, see photograph below:</p>

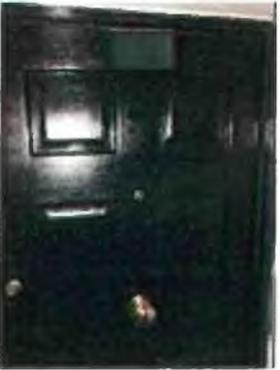
27	G-27	<p>The flat entrance door to property [redacted] does not appear to be fire resisting, see photograph below:</p>

<p>During the next maintenance works at the property, consideration should be given to replacing the entrance door to property [redacted] to ensure its compliance with British Standard 476.</p> <p>(It should be confirmed as non-fire resisting once opened and inspected).</p>	4	X			
28	2 and 7	<p>The additional issues were noted with regards to fire doors within the block:</p> <p>The lobby fire door on the 2nd and 7<sup>th</sup> floors are not shutting tightly into their frame. See photographs below:</p>

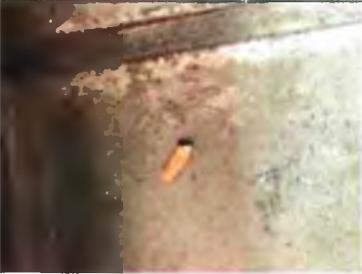
29	G-27	<p>It was noted that smoking takes place in the following area:</p> <ul style="list-style-type: none"> <li>• Along the staircase</li> </ul> <p>For example, see photograph below.</p>

<p>Residents must never smoke within any common parts of the building or within close proximity to the building. These cigarette ends/packs should be discarded off immediately.</p>	1	X			
30	G-27	<p>There are obstructions within the flat lobby areas on the 3<sup>rd</sup>, 17<sup>th</sup> and 26<sup>th</sup> floors. See photographs below.</p>
