# **FIRE RISK ASSESSMENT**

Galleon House 2016

<b>Premises Address:</b> <i>Galleon House Glengarnock Avenue, London, E14 3DJ</i>	<b>Use of Premises:</b> <i>Residential block.</i>
<b>Date of Risk Assessment:</b> <i>8 December 2016</i>	<b>Date of Review:</b> <i>8 December 2018</i>

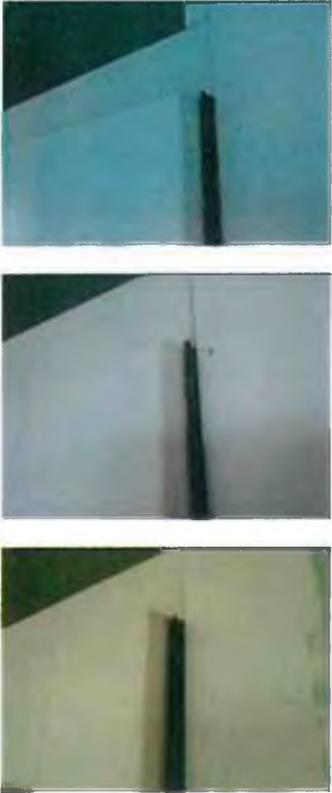
<p>During the next maintenance works at the property, consideration should be given to replacing the entrance door to property ■ to ensure its compliance with British Standard 476.</p>	4	X	
19	G-10	<p>The lobby fire doors from floors 1, 5 and 9 from the staircase area do not shut tightly into their frame. The ground floor fire door was also wedged open opposite the concierge office. See photographs below.</p>

<p>These doors should be repaired so they shut tightly into their frame.</p> <p>Fire doors must never be wedged open.</p>	4	X
