# **FIRE RISK ASSESSMENT**

Gordon House

<b>Premises Address:</b> Gordon House Glamis Road London, E1 2BU	<b>Use of Premises:</b> Residential block.
<b>Date of Risk Assessment:</b> 23 February 2017	<b>Date of Review:</b> 23 February 2018

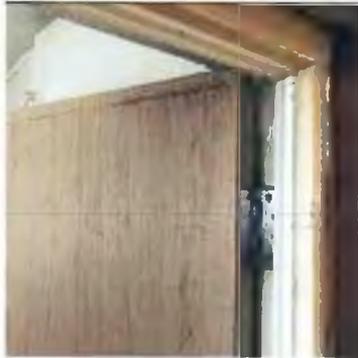
Item number	Floor	Remedial Works	Actions	Priority / tested and satisfactory / not applicable	Housing Centre	Asset Management	Regeneration	Date Rectified
1	G-19	<p>The flat entrance door to property ■ was inspected during the assessment and the following observation noted:</p> <p>It is a compliant fire door but is not fitted with a self-closer, intumescent strips and smoke seals. See photograph below.</p>

<p>(DOOR INSPECTED)</p>	<p>During the next maintenance works at the property, consideration should be given to adding a self-closer, intumescent strips and smoke seals to the front entrance door to property ■ to ensure its compliance with British Standard 476.</p>	4	X			
2	G-19	<p>The flat entrance door to property ■ was inspected during the assessment and the following observation noted:</p> <p>It is a compliant fire door and is fitted with a self-closing device, intumescent strip and cold smoke seal. See photograph below.</p>	<p>No action required.</p>

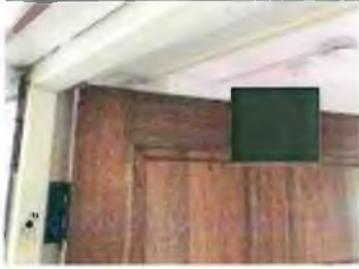
<p>(DOOR INSPECTED)</p>						
3	G-19	<p>The flat entrance door to property ■ was inspected during the assessment and the following observation noted:</p> <p>It could not be confirmed as a compliant fire door and is not fitted with a self-closer, intumescent strips and smoke seals. See photograph below.</p>

<p>(DOOR INSPECTED)</p>	<p>During the next maintenance works at the property, consideration should be given to replacing the entrance door to property ■ to ensure its compliance with British Standard 476.</p>	4	X			
4	G-19	<p>The flat entrance door to property ■ was inspected during the assessment and the following observation noted:</p> <p>It is a compliant fire door and is fitted with intumescent strips and smoke seals but no self-closer. See photograph below.</p>

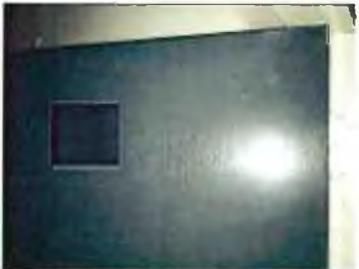
5	G-19	<p>The flat entrance door to property ■ was inspected during the assessment and the following observation noted:</p> <p>It is a compliant fire door and is fitted with a self-closing device, intumescent strip and cold smoke seal. See photograph below.</p>

<p>(DOOR INSPECTED)</p>	No action required.			
6	G-19	<p>The flat entrance door to property ■ was inspected during the assessment and the following observation noted:</p> <p>It is a compliant fire door and is fitted with a self-closing device, intumescent strip and cold smoke seal. See photograph below.</p>

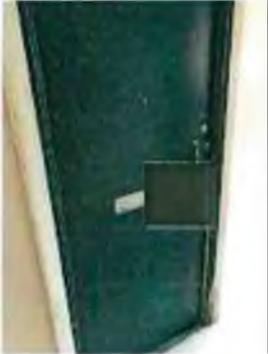
(DOOR INSPECTED)						
8	G-19	<p>The flat entrance door to property ■ does not appear to be fire resisting, see photograph below:</p>

<p>During the next maintenance works at the property, consideration should be given to replacing the entrance door to property ■ to ensure its compliance with British Standard 476.</p> <p>(It should be confirmed as non-fire resisting once opened and inspected).</p>	4	X			
9	G-19	<p>The flat entrance door to property ■ does not appear to be fire resisting, see photograph below:</p>

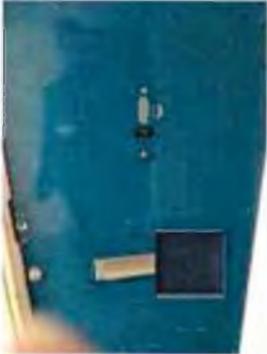
11	G-19	<p>The flat entrance door to property ■ does not appear to be fire resisting, see photograph below:</p>

<p>During the next maintenance works at the property, consideration should be given to replacing the entrance door to property ■ to ensure its compliance with British Standard 476.</p> <p>(It should be confirmed as non-fire resisting once opened and inspected).</p>	4	X		
12	G-19	<p>The flat entrance door to property ■ does not appear to be fire resisting, see photograph below:</p>

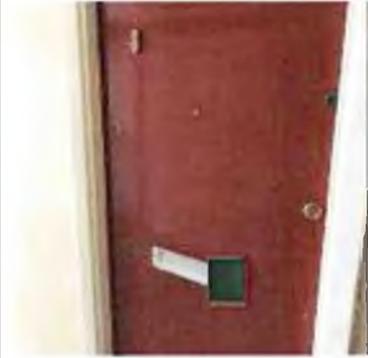
14	G-19	<p>The flat entrance door to property ■ does not appear to be fire resisting, see photograph below:</p>

<p>During the next maintenance works at the property, consideration should be given to replacing the entrance door to property ■ to ensure its compliance with British Standard 476.</p> <p>(It should be confirmed as non-fire resisting once opened and inspected).</p>	4	X			
15	G-19	<p>The flat entrance door to property ■ does not appear to be fire resisting, see photograph below:</p>

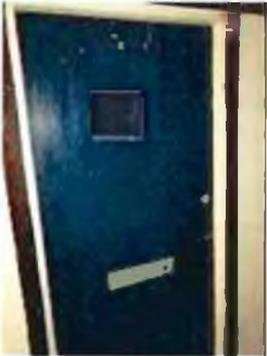
17	G-19	<p>The flat entrance door to property ■ does not appear to be fire resisting, see photograph below:</p>

<p>During the next maintenance works at the property, consideration should be given to replacing the entrance door to property ■ to ensure its compliance with British Standard 476.</p> <p>(It should be confirmed as non-fire resisting once opened and inspected).</p>	4	X		
18	G-19	<p>The flat entrance door to property ■ does not appear to be fire resisting, see photograph below:</p>

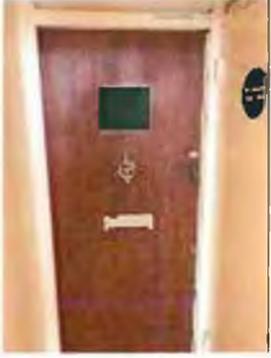
20	G-19	<p>The flat entrance door to property ■ does not appear to be fire resisting, see photograph below:</p>

<p>During the next maintenance works at the property, consideration should be given to replacing the entrance door to property ■ to ensure its compliance with British Standard 476.</p> <p>(It should be confirmed as non-fire resisting once opened and inspected).</p>	4	X				
21	G-19	<p>The flat entrance door to property ■ does not appear to be fire resisting, see photograph below:</p>

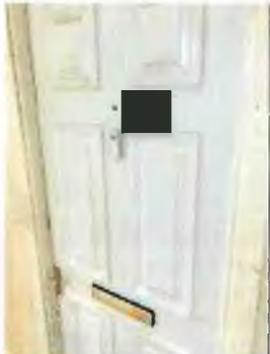
22	G-19	<p>The flat entrance door to property ■ does not appear to be fire resisting, see photograph below:</p>

<p>During the next maintenance works at the property, consideration should be given to replacing the entrance door to property ■ to ensure its compliance with British Standard 476.</p> <p>(It should be confirmed as non-fire resisting once opened and inspected).</p>	4	X			
23	G-19	<p>The flat entrance door to property ■ does not appear to be fire resisting, see photograph below:</p>

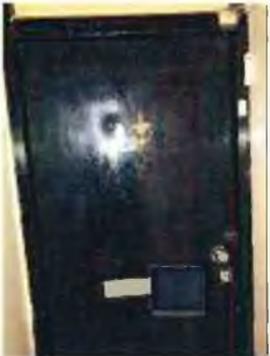
<p>During the next maintenance works at the property, consideration should be given to replacing the entrance door to property ■ to ensure its compliance with British Standard 476.</p> <p>(It should be confirmed as non-fire resisting once opened and inspected).</p>	4	X			
24	G-19	<p>The flat entrance door to property ■ does not appear to be fire resisting, see photograph below:</p>

<p>During the next maintenance works at the property, consideration should be given to replacing the entrance door to property ■ to ensure its compliance with British Standard 476.</p> <p>(It should be confirmed as non-fire resisting once opened and inspected).</p>	4	X

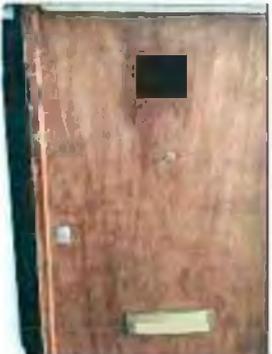
<p>During the next maintenance works at the property, consideration should be given to replacing the entrance door to property ■ to ensure its compliance with British Standard 476.</p> <p>(It should be confirmed as non-fire resisting once opened and inspected).</p>	4	X			
27	G-19	<p>The flat entrance door to property ■ does not appear to be fire resisting, see photograph below:</p>

<p>During the next maintenance works at the property, consideration should be given to replacing the entrance door to property ■ to ensure its compliance with British Standard 476.</p> <p>(It should be confirmed as non-fire resisting once opened and inspected).</p>	4	X

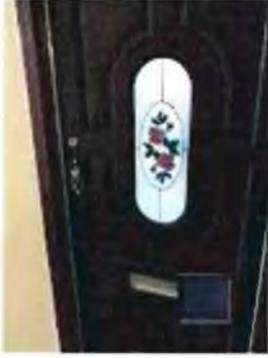
28	G-19	<p>The flat entrance door or glazing to property ■ does not appear to be resisting, see photograph below:</p>

<p>During the next maintenance works at the property, consideration should be given to replacing the entrance door and glazing to property ■ to ensure its compliance with British Standard 476.</p> <p>(It should be confirmed as non-fire resisting once opened and inspected).</p>	4	X	
29	G-19	<p>The flat entrance door or glazing to property ■ does not appear to be resisting, see photograph below:</p>

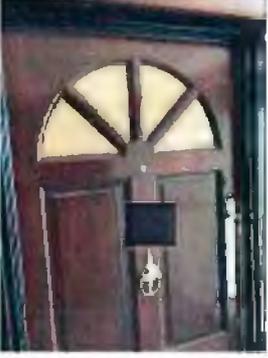
<p>During the next maintenance works at the property, consideration should be given to replacing the entrance door and glazing to property ■ to ensure its compliance with British Standard 476.</p> <p>(It should be confirmed as non-fire resisting once opened and inspected).</p>	4	X	
30	G-19	<p>The flat entrance door or glazing to property ■ does not appear to be resisting, see photograph below:</p>

<p>During the next maintenance works at the property, consideration should be given to replacing the entrance door and glazing to property ■ to ensure its compliance with British Standard 476.</p> <p>(It should be confirmed as non-fire resisting once opened and inspected).</p>	4	X

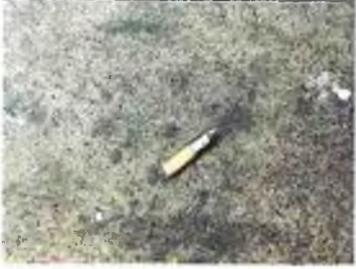
33	1	<p>It was noted that smoking takes place in the following area:</p> <ul style="list-style-type: none"> <li>• First floor lobby area</li> </ul> <p>See photograph below.</p>

<p><b>Residents must never smoke within any common parts of the building or within close proximity to the building. These cigarette ends/packs/ashtrays should be discarded off immediately.</b></p>	1	X	
----	---	---	--	---	---	--
