FIRE RISK ASSESSMENT

Grafton House

Premises Address: <i>Grafton House Wellington Way London, E3 4NG</i>	Use of Premises: <i>Residential block.</i>
Date of Risk Assessment: 14 March 2017	Date of Review: 14 March 2018

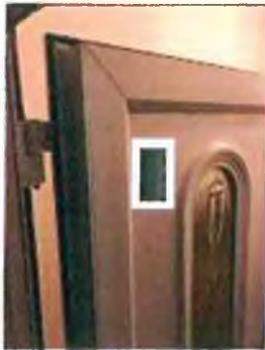
Item number	Floor	Remedial Works	Actions	Priority / tested and satisfactory / not applicable	Housing Centre	Asset Management	Date Rectified
1	G-21	<p>The flat entrance door and glazing to property ■ was inspected during the assessment and the following observation noted:</p> <p>It does not appear to be a compliant fire door and glazing. See photograph below:</p>

<p>(DOOR INSPECTED)</p>	<p>During the next maintenance works at the property, consideration should be given to replacing the entrance door and glazing to property ■ to ensure its compliance with British Standard 476.</p>	4	X		
2	G-21	<p>The flat entrance door to property ■ was inspected during the assessment and the following observation noted:</p> <p>It does not appear to be a compliant fire door. See photograph below:</p>	<p>During the next maintenance works at the property, consideration should be given to replacing the entrance door to property ■ to ensure its compliance with British Standard 476.</p>	4	X

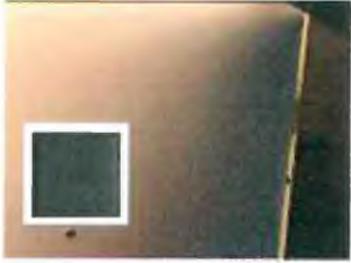
<p><i>(DOOR INSPECTED)</i></p>						
3	G-21	<p>The flat entrance door to property ■ was inspected during the assessment and the following observation noted:</p> <p><i>It is a compliant fire door but has no self-closing device. See photograph below.</i></p>

<p><i>During the next maintenance works at the property, consideration should be given to adding a self-closing device to property ■ to ensure its compliance with British Standard 476.</i></p>	4	X			
		<p><i>(DOOR INSPECTED)</i></p>						
4	G-21	<p>The flat entrance door to property ■ was inspected during the assessment and the following observation noted:</p> <p><i>It is a compliant fire door (Russell) but has no self-closing device. See photograph below.</i></p>

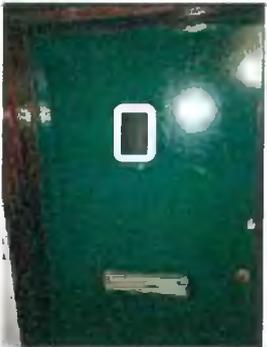
<i>(DOOR INSPECTED)</i>						
8	G-21	<i>The flat entrance door to property ■ does not appear to be the original fire door and could not be confirmed as fire resisting, see photograph below:</i>

<i>During the next maintenance works at the property, consideration should be given to replacing the entrance door to property ■ to ensure its compliance with British Standard 476.</i> <i>(It should be confirmed as non-fire resisting once opened and inspected).</i>	4	X		
9	G-21	<i>The flat entrance door to property ■ does not appear to be the original fire door and could not be confirmed as fire resisting, see photograph below:</i>

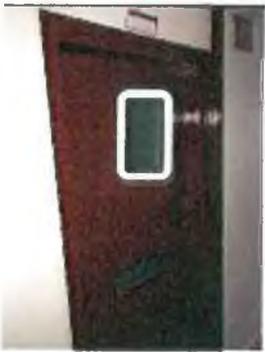
<i>opened and inspected).</i>					
11	G-21	<p>The flat entrance door to property ■ does not appear to be the original fire door and could not be confirmed as fire resisting, see photograph below:</p>

<p>During the next maintenance works at the property, consideration should be given to replacing the entrance door to property ■ to ensure its compliance with British Standard 476.</p> <p>(It should be confirmed as non-fire resisting once opened and inspected).</p>	4	X			
12	G-21	<p>The flat entrance door to property ■ does not appear to be the original fire door and could not be confirmed as fire resisting, see photograph below:</p>

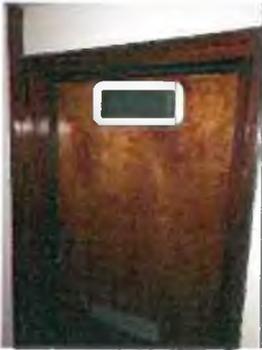
14	G-21	<p>The flat entrance door to property ■ does not appear to be the original fire door and could not be confirmed as fire resisting, see photograph below:</p>

<p>During the next maintenance works at the property, consideration should be given to replacing the entrance door to property ■ to ensure its compliance with British Standard 476.</p> <p>(It should be confirmed as non-fire resisting once opened and inspected).</p>	4	X			
15	G-21	<p>The flat entrance door to property ■ does not appear to be the original fire door and could not be confirmed as fire resisting, see photograph below:</p>

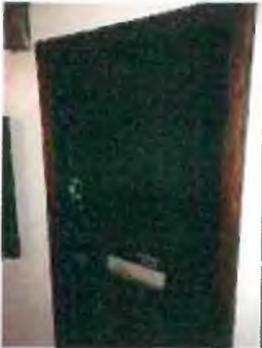
17	G-21	<p>The flat entrance door to property ■ does not appear to be the original fire door and could not be confirmed as fire resisting, see photograph below:</p>

<p>During the next maintenance works at the property, consideration should be given to replacing the entrance door to property ■ to ensure its compliance with British Standard 476.</p> <p>(It should be confirmed as non-fire resisting once opened and inspected).</p>	4	X			
18	G-21	<p>The flat entrance door to property ■ does not appear to be the original fire door and could not be confirmed as fire resisting, see photograph below:</p>

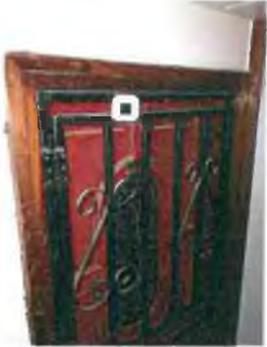
20	G-21	<p>The flat entrance door and glazing to property ■ does not appear to be the original and could not be confirmed as fire resisting, see photograph below:</p>

<p>During the next maintenance works at the property, consideration should be given to replacing the entrance door and glazing to property ■ to ensure its compliance with British Standard 476.</p> <p>(It should be confirmed as non-fire resisting once opened and inspected).</p>	4	X			
21	G-21	<p>The flat entrance door and glazing to property ■ does not appear to be the original and could not be confirmed as fire resisting, see photograph below:</p>

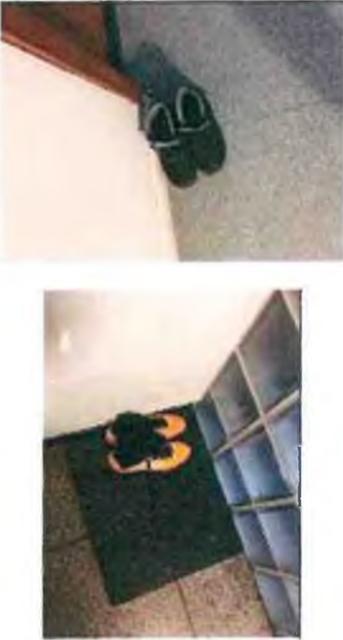
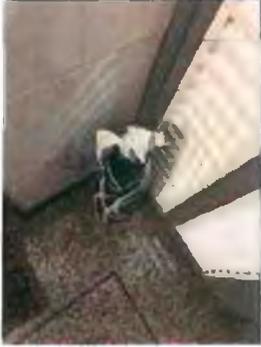
26	G-21	<p>There are shoes and other items stored within the common areas. See photographs below.</p>

<p>Residents should be advised to keep the common areas, staircases and areas outside their flats clear, sterile and unobstructed at all times. These fire escape routes must be protected at all times. This also includes around the perimeter of the building to reduce the chances of an arson attack.</p>	1	X

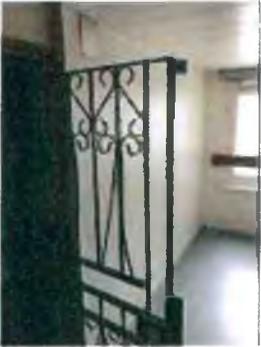
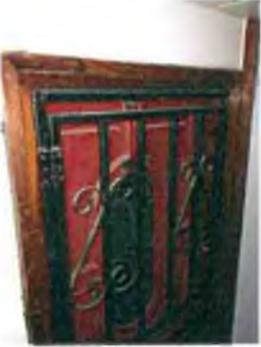
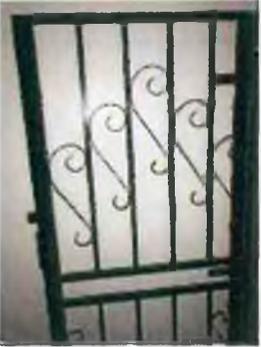
27	G-21	<p>Security gates have been installed to flats [REDACTED]. For example, see photographs below.</p>

<p>Eastend homes should continue with the policy of informing their tenants about the use and safety of security gates.</p>	3	X
