FIRE RISK ASSESSMENT

Hatton House

Premises Address: Hatton House Hindmarsh Close London, E1	Use of Premises: Residential block.
Date of Risk Assessment: 10 March 2017	Date of Review: 10 March 2018

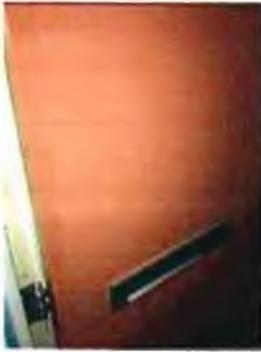
<i>Item number</i>	Floor	Remedial Works	Actions	Priority/tested and satisfactory/not	Housing Centre	Asset Management	Regen	Date Rectified
1	G-22	<p>The flat entrance door to property ■ was inspected during the assessment and the following observation noted:</p> <p>It is a compliant fire door but is not fitted with a self-closer, intumescent strips and smoke seals. See photograph below.</p>

<p>(DOOR INSPECTED)</p>	<p>During the next maintenance works at the property, consideration should be given to adding a self-closer, intumescent strips and smoke seals to the front entrance door to property ■ to ensure its compliance with British Standard 476.</p>	4	X			
2	G-22	<p>The flat entrance door to property ■ was inspected during the assessment and the following observation noted:</p> <p>It is a compliant fire door but is not fitted with a self-closer, intumescent strips and smoke seals. See photograph below.</p>	<p>During the next maintenance works at the property, consideration should be given to adding a self-closer, intumescent strips and smoke seals to the front entrance door to property ■ to ensure its compliance with British Standard 476.</p>	4	X

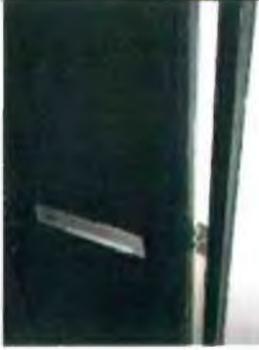
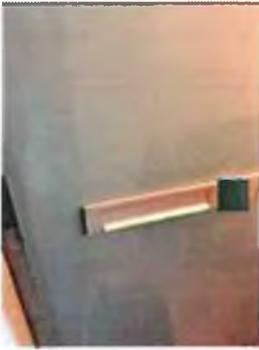
(DOOR INSPECTED)							
3	G-22	<p>The flat entrance door to property ■ was inspected during the assessment and the following observation noted:</p> <p>It is a compliant fire door but is not fitted with a self-closer, intumescent strips and smoke seals. See photograph below.</p>

<p>During the next maintenance works at the property, consideration should be given to adding a self-closer, intumescent strips and smoke seals to the front entrance door to property ■ to ensure its compliance with British Standard 476.</p>	4	X				
		(DOOR INSPECTED)							
4	G-22	<p>The flat entrance door to property ■ does not appear to be fire resisting, see photograph below:</p>

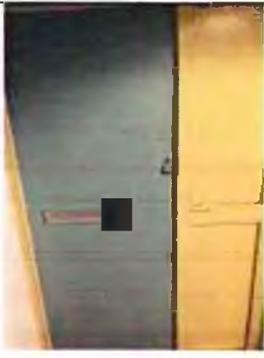
5	G-22	<p>The flat entrance door to property ■ does not appear to be fire resisting, see photograph below:</p>	<p>During the next maintenance works at the property, consideration should be given to replacing the entrance door to property ■ to ensure its compliance with</p>	4	X

British Standard 476. <i>(It should be confirmed as non-fire resisting once opened and inspected).</i>					
6	G-22	<i>The flat entrance door to property ■ does not appear to be fire resisting, see photograph below:</i>

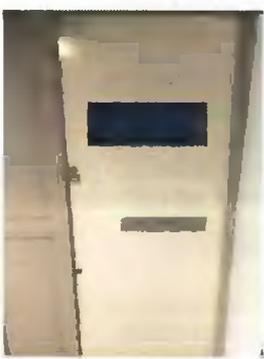
During the next maintenance works at the property, consideration should be given to replacing the entrance door to property ■ to ensure its compliance with British Standard 476. <i>(It should be confirmed as non-fire resisting once opened and inspected).</i>	4	X			
7	G-22	<i>The flat entrance door to property ■ does not appear to be fire resisting, see photograph below:</i>

During the next maintenance works at the property, consideration should be given to replacing the entrance door to property ■ to ensure its compliance with British Standard 476. <i>(It should be confirmed as non-fire resisting once opened and inspected).</i>	4	X			
8	G-22	<i>The flat entrance door to property ■ does not appear to be fire resisting, see photograph below:</i>	During the next maintenance works at the property, consideration should be given to replacing the entrance door to property ■ to ensure its compliance with British Standard 476. <i>(It should be confirmed as non-fire resisting once opened and inspected).</i>	4	X

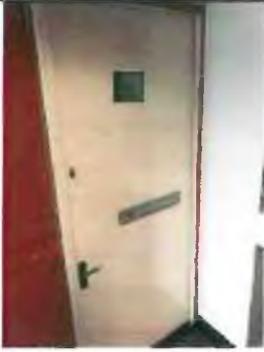
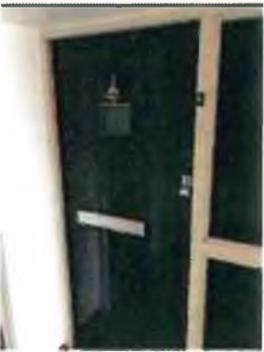
9	G-22	<p>The flat entrance door to property ■ does not appear to be fire resisting, see photograph below:</p>

<p>During the next maintenance works at the property, consideration should be given to replacing the entrance door to property ■ to ensure its compliance with British Standard 476.</p> <p>(It should be confirmed as non-fire resisting once opened and inspected).</p>	4	X			
10	G-22	<p>The flat entrance door to property ■ does not appear to be fire resisting, see photograph below:</p>

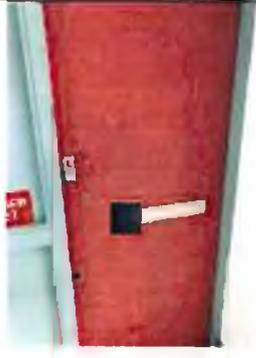
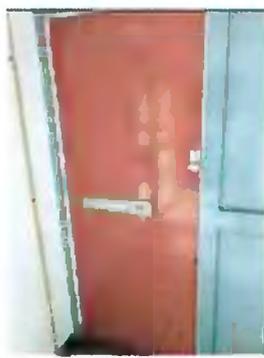
12	G-22	<p>The flat entrance door to property ■ does not appear to be fire resisting, see photograph below:</p>

<p>During the next maintenance works at the property, consideration should be given to replacing the entrance door to property ■ to ensure its compliance with British Standard 476.</p> <p>(It should be confirmed as non-fire resisting once opened and inspected).</p>	4	X			
13	G-22	<p>The flat entrance door to property ■ does not appear to be fire resisting, see photograph below:</p>

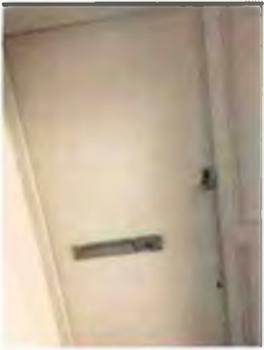
15	G-22	<p>The flat entrance door to property ■ does not appear to be fire resisting, see photograph below:</p>

<p>During the next maintenance works at the property, consideration should be given to replacing the entrance door to property ■ to ensure its compliance with British Standard 476.</p> <p>(It should be confirmed as non-fire resisting once opened and inspected).</p>	4	X			
16	G-22	<p>Many of the balcony fire doors are part missing their strips and seals. The door on floor 12 is also damaged. For example, see photographs below:</p>

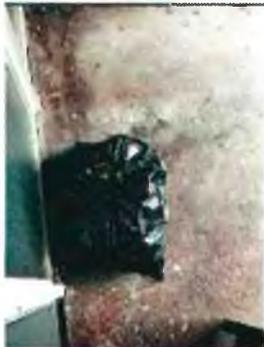
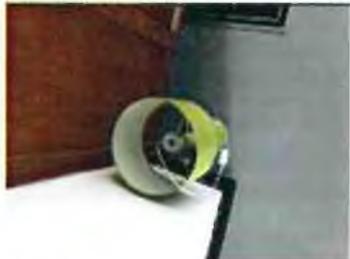
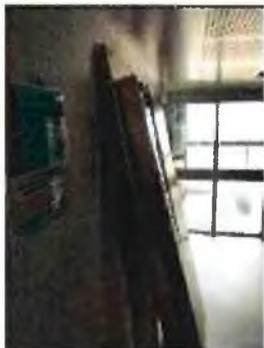
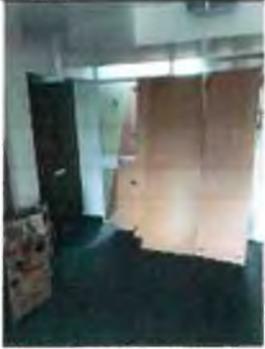
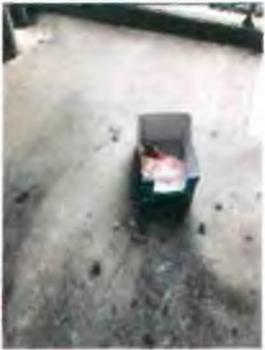
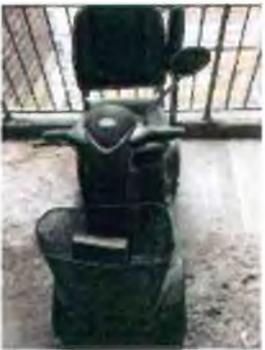
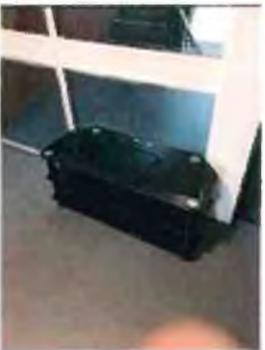
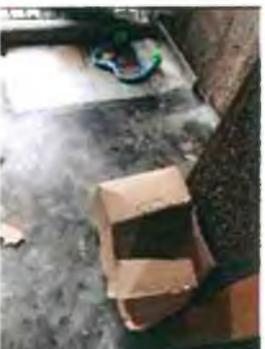
17	G-22	<p><i>There are obstructions within the flat lobby areas and on the external balconies throughout the block. For example, see photographs below.</i></p>

<p><i>Residents should be advised to keep the common areas, staircases and areas outside their flats clear, sterile and unobstructed at all times. These fire escape routes must be protected at all times. This also includes around the perimeter of the building to reduce the chances of an arson attack.</i></p>	1	X

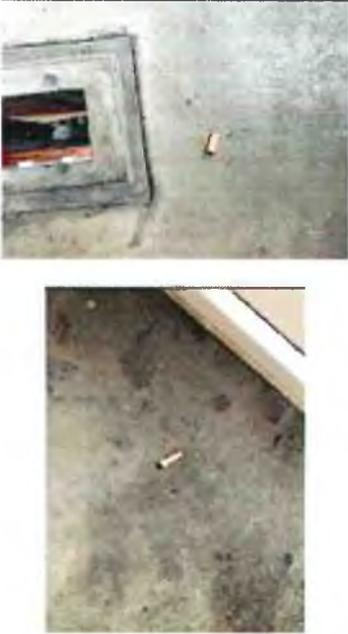
18	G-22	<p>It was noted that smoking takes place in the following areas;</p> <ul style="list-style-type: none"> • Along the staircase <p>See photographs below.</p>

<p>Residents must never smoke within any common parts of the building or within close proximity to the building. These cigarette ends/packs/ashtrays should be discarded off immediately.</p>	1	X			
----	------	---	--	---	---	--	--	--
