FIRE RISK ASSESSMENT

Stockholm House

Premises Address: Stockholm House Swedenborg Gardens London, E1 8HR	Use of Premises: Residential block.
Date of Risk Assessment: 10 March 2017	Date of Review: 10 March 2018

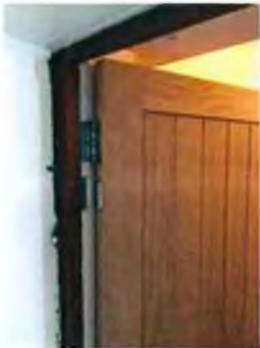
Item number	Floor	Remedial Works	Actions	Priority/ tested and satisfactory/ not applicable	Housing Centre	Asset Management	Date Rectified
1	G-18	<p>The flat entrance door to property ■ was inspected during the assessment and the following observation noted:</p> <p>It is a compliant fire door but is not fitted with a self-closer, intumescent strips and smoke seals. See photograph below.</p>

<p>(DOOR INSPECTED)</p>	<p>During the next maintenance works at the property, consideration should be given to adding a self-closer, intumescent strips and smoke seals to the front entrance door to property ■ to ensure its compliance with British Standard 476.</p>	4	X		
2	G-18	<p>The flat entrance door to property ■ was inspected during the assessment and the following observation noted:</p> <p>It is a compliant fire door but is not fitted with a self-closer, intumescent strips and smoke seals. See photograph below.</p>	<p>During the next maintenance works at the property, consideration should be given to adding a self-closer, intumescent strips and smoke seals to the front entrance door to property ■ to ensure its compliance with British Standard 476.</p>	4	X

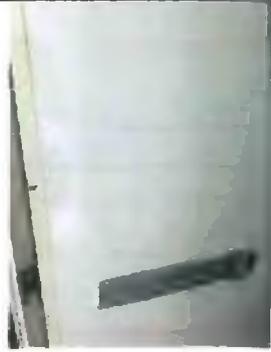
(DOOR INSPECTED)						
3	G-18	<p>The flat entrance door to property ■ was inspected during the assessment and the following observation noted:</p> <p>It is a compliant fire door but is not fitted with a self-closer, intumescent strips and smoke seals. See photograph below.</p>

<p>During the next maintenance works at the property, consideration should be given to adding a self-closer, intumescent strips and smoke seals to the front entrance door to property ■ to ensure its compliance with British Standard 476.</p>	4	X			
		(DOOR INSPECTED)						
4	G-18	<p>The flat entrance door to property ■ does not appear to be fire resisting, see photograph below:</p>

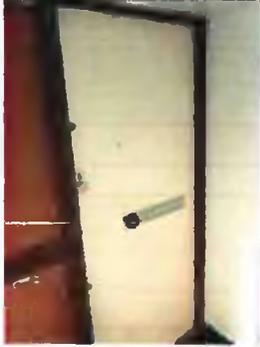
5	G-18	<p>The flat entrance door to property ■ does not appear to be fire resisting, see photograph below:</p>	<p>During the next maintenance works at the property, consideration should be given to replacing the entrance door to property ■ to ensure its compliance with British Standard 476.</p>	4	X

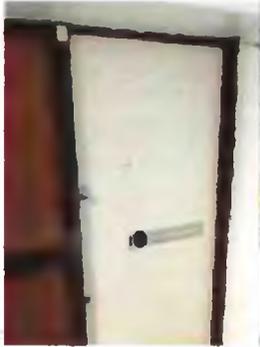
<i>(It should be confirmed as non-fire resisting once opened and inspected).</i>					
6	G-18	<p>The flat entrance door to property ■ does not appear to be fire resisting, see photograph below:</p>

<p>During the next maintenance works at the property, consideration should be given to replacing the entrance door to property ■ to ensure its compliance with British Standard 476.</p> <p><i>(It should be confirmed as non-fire resisting once opened and inspected).</i></p>	4	X			
7	G-18	<p>The flat entrance door to property ■ does not appear to be fire resisting, see photograph below:</p>

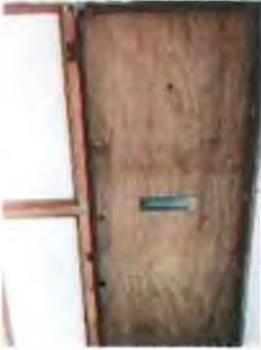
9	G-18	<p>The flat entrance door to property ■ does not appear to be fire resisting, see photograph below:</p>

<p>During the next maintenance works at the property, consideration should be given to replacing the entrance door to property ■ to ensure its compliance with British Standard 476.</p> <p>(It should be confirmed as non-fire resisting once opened and inspected).</p>	4	X			
10	G-18	<p>The flat entrance door to property ■ does not appear to be fire resisting, see photograph below:</p>

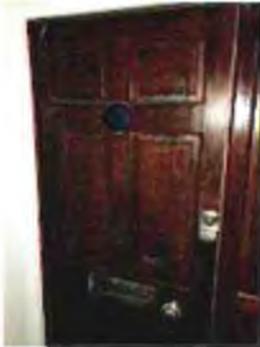
12	G-18	<p>The flat entrance door to property ■ does not appear to be fire resisting, see photograph below:</p>

<p>During the next maintenance works at the property, consideration should be given to replacing the entrance door to property ■ to ensure its compliance with British Standard 476.</p> <p>(It should be confirmed as non-fire resisting once opened and inspected).</p>	4	X			
13	G-18	<p>The flat entrance door to property ■ does not appear to be fire resisting, see photograph below:</p>

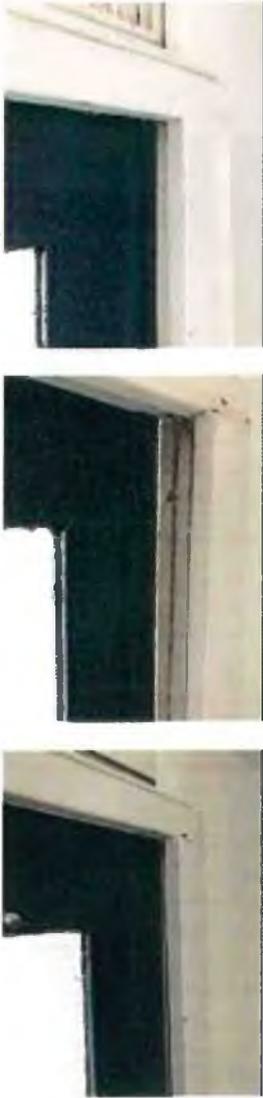
15	G-18	<p>Many of the balcony fire doors protecting the lobbies were not shutting tightly into their frames (floors 1, 5, 7, 8). See photographs below:</p>

<p>During the next maintenance works at the property, it should be ensured all lobby fire doors shut tightly into their frames.</p>	4	X

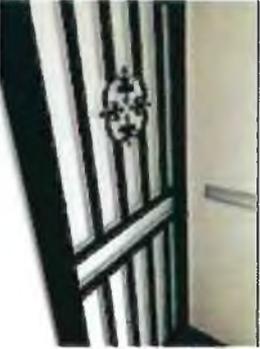
18	G-18	<p>Security gates have been installed to flat ■. See photograph below.</p>

<p><i>Eastend homes should continue with the policy of informing their tenants about the use and safety of security gates.</i></p>	3	X			
19	13	<p>The bell to door ■ has burn marks, see photograph below:</p>
