FIRE RISK ASSESSMENT

Denning Point

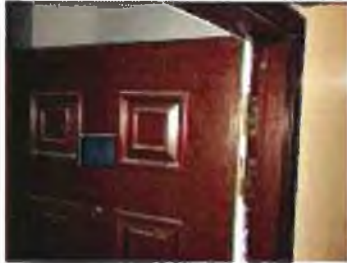
| 5 | G-20 | <p>The flat entrance door to property ■ was inspected during the assessment and the following observation noted:</p> <p>It is a compliant fire door but is not fitted with a self-closer, intumescent strips and smoke seals. See photograph below.</p> | <p>During the next maintenance works at the property, consideration should be given to adding a self-closer, intumescent strips and smoke seals to the front entrance door to property ■ to ensure its compliance with British Standard 476.</p> | 4 | X | | | |

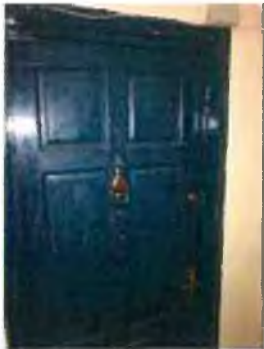
| 9 | G-20 | <p>The flat entrance door to property ■ does not appear to be fire resisting, see photograph below:</p> | <p>During the next maintenance works at the property, consideration should be given to replacing the entrance door to property ■ to ensure its compliance with British Standard 476.</p> <p><i>(It should be confirmed as non-fire resisting once opened and inspected).</i></p> | 4 | X | | | |

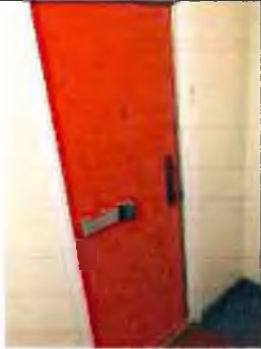
| 10 | G-20 | <p>The flat entrance door to property ■ does not appear to be fire resisting, see photograph below:</p> | <p>During the next maintenance works at the property, consideration should be given to replacing the entrance door to property ■ to ensure its compliance with British Standard 476.</p> <p><i>(It should be confirmed as non-fire resisting once opened and inspected).</i></p> | 4 | X | | | |

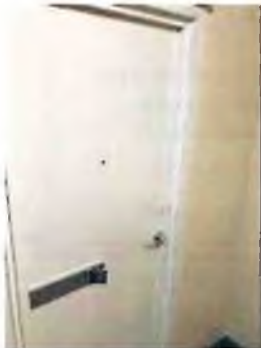
| 11 | G-20 | <p>The flat entrance door to property ■ does not appear to be fire resisting, see photograph below:</p> | <p>During the next maintenance works at the property, consideration should be given to replacing the entrance door to property ■ to ensure its compliance with British Standard 476.</p> <p>(It should be confirmed as non-fire resisting once opened and inspected).</p> | 4 | X | | |

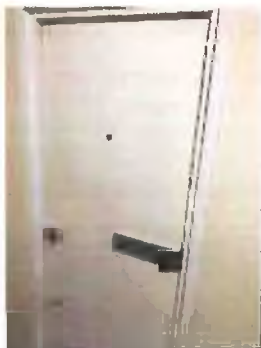
| 12 | G-20 | <p>The flat entrance door to property ■ does not appear to be fire resisting, see photograph below:</p> | <p>During the next maintenance works at the property, consideration should be given to replacing the entrance door to property ■ to ensure its compliance with British Standard 476.</p> <p>(It should be confirmed as non-fire resisting once opened and inspected).</p> | 4 | X | | |

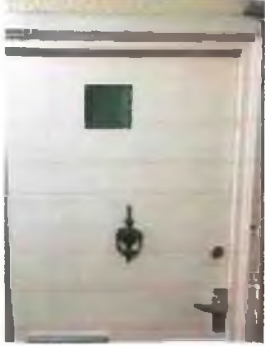
| 13 | G-20 | <p>The flat entrance door to property ■ does not appear to be fire resisting, see photograph below:</p> | <p>During the next maintenance works at the property, consideration should be given to replacing the entrance door to property ■ to ensure its compliance with British Standard 476.</p> <p>(It should be confirmed as non-fire resisting once opened and inspected).</p> | 4 | X | | |

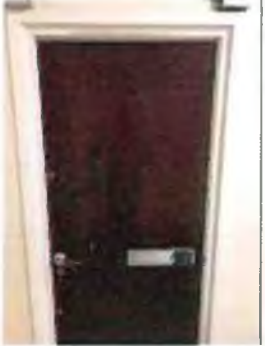
| 14 | G-20 | <p>The flat entrance door to property ■ does not appear to be fire resisting, see photograph below:</p> | <p>During the next maintenance works at the property, consideration should be given to replacing the entrance door to property ■ to ensure its compliance with British Standard 476.</p> <p>(It should be confirmed as non-fire resisting once opened and inspected).</p> | 4 | X | | | |

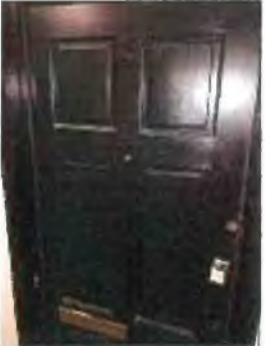
| 15 | G-20 | <p>The flat entrance door to property ■ does not appear to be fire resisting, see photograph below:</p> | <p>During the next maintenance works at the property, consideration should be given to replacing the entrance door to property ■ to ensure its compliance with British Standard 476.</p> <p>(It should be confirmed as non-fire resisting once opened and inspected).</p> | 4 | X | | | |

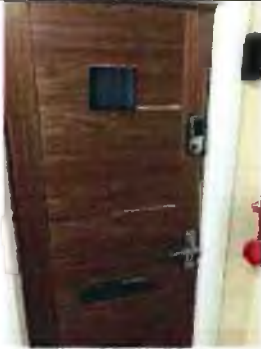
| 16 | G-20 | <p>The flat entrance door to property ■ does not appear to be fire resisting, see photograph below:</p> | <p>During the next maintenance works at the property, consideration should be given to replacing the entrance door to property ■ to ensure its compliance with British Standard 476.</p> <p>(It should be confirmed as non-fire resisting once opened and inspected).</p> | 4 | | | | |

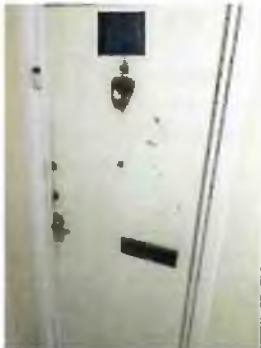
| 17 | G-20 | <p>The flat entrance door to property ■ does not appear to be fire resisting, see photograph below:</p> | <p>During the next maintenance works at the property, consideration should be given to replacing the entrance door to property ■ to ensure its compliance with British Standard 476.</p> <p>(It should be confirmed as non-fire resisting once opened and inspected).</p> | 4 | X | | |

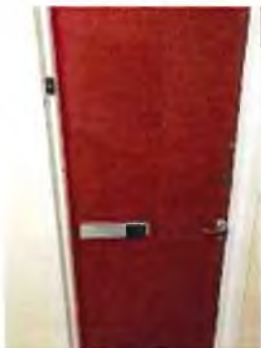
| 18 | G-20 | <p>The flat entrance door to property ■ does not appear to be fire resisting, see photograph below:</p> | <p>During the next maintenance works at the property, consideration should be given to replacing the entrance door to property ■ to ensure its compliance with British Standard 476.</p> <p>(It should be confirmed as non-fire resisting once opened and inspected).</p> | 4 | X | | |

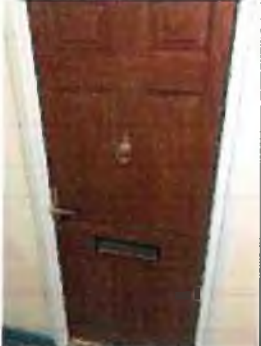
| 19 | G-20 | <p>The flat entrance door to property ■ does not appear to be fire resisting, see photograph below:</p> | <p>During the next maintenance works at the property, consideration should be given to replacing the entrance door to property ■ to ensure its compliance with British Standard 476.</p> <p>(It should be confirmed as non-fire resisting once opened and inspected).</p> | 4 | X | | |

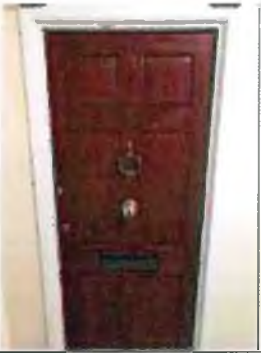
| 20 | G-20 | <p>The flat entrance door to property ■ does not appear to be fire resisting, see photograph below:</p> | <p>During the next maintenance works at the property, consideration should be given to replacing the entrance door to property ■ to ensure its compliance with British Standard 476.</p> <p>(It should be confirmed as non-fire resisting once opened and inspected).</p> | 4 | X | | | | |

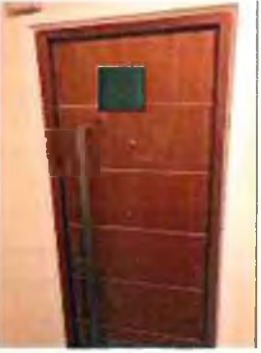
| 21 | G-20 | <p>The flat entrance door to property ■ does not appear to be fire resisting, see photograph below:</p> | <p>During the next maintenance works at the property, consideration should be given to replacing the entrance door to property ■ to ensure its compliance with British Standard 476.</p> <p>(It should be confirmed as non-fire resisting once opened and inspected).</p> | 4 | X | | | | |

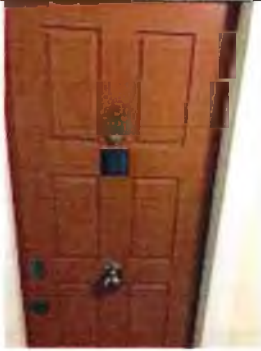
| 22 | G-20 | <p>The flat entrance door to property ■ does not appear to be fire resisting, see photograph below:</p> | <p>During the next maintenance works at the property, consideration should be given to replacing the entrance door to property ■ to ensure its compliance with British Standard 476.</p> <p>(It should be confirmed as non-fire resisting once opened and inspected).</p> | 4 | X | | | | |

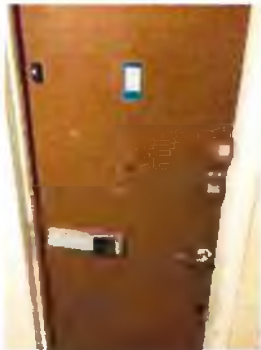
| 23 | G-20 | <p>The flat entrance door to property ■ does not appear to be fire resisting, see photograph below:</p> | <p>During the next maintenance works at the property, consideration should be given to replacing the entrance door to property ■ to ensure its compliance with British Standard 476.</p> <p>(It should be confirmed as non-fire resisting once opened and inspected).</p> | 4 | X | | | |

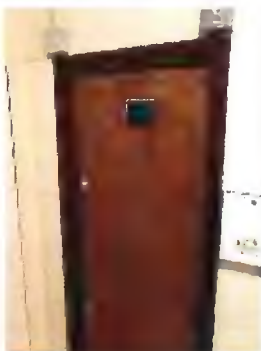
| 24 | G-20 | <p>The flat entrance door to property ■ does not appear to be fire resisting, see photograph below:</p> | <p>During the next maintenance works at the property, consideration should be given to replacing the entrance door to property ■ to ensure its compliance with British Standard 476.</p> <p>(It should be confirmed as non-fire resisting once opened and inspected).</p> | 4 | X | | | |

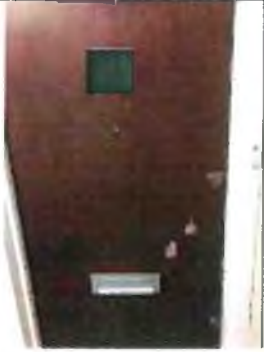
| 25 | G-20 | <p>The flat entrance door to property ■ does not appear to be fire resisting, see photograph below:</p> | <p>During the next maintenance works at the property, consideration should be given to replacing the entrance door to property ■ to ensure its compliance with British Standard 476.</p> <p>(It should be confirmed as non-fire resisting once opened and inspected).</p> | 4 | X | | | |

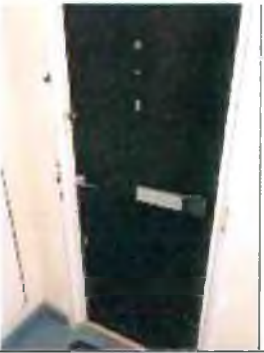
| 26 | G-20 | <p>The flat entrance door to property ■ does not appear to be fire resisting, see photograph below:</p> | <p>During the next maintenance works at the property, consideration should be given to replacing the entrance door to property ■ to ensure its compliance with British Standard 476.</p> <p>(It should be confirmed as non-fire resisting once opened and inspected).</p> | 4 | X | | | |

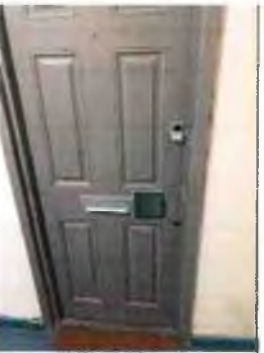
| 27 | G-20 | <p>The flat entrance door to property ■ does not appear to be fire resisting, see photograph below:</p> | <p>During the next maintenance works at the property, consideration should be given to replacing the entrance door to property ■ to ensure its compliance with British Standard 476.</p> <p>(It should be confirmed as non-fire resisting once opened and inspected).</p> | 4 | X | | | |

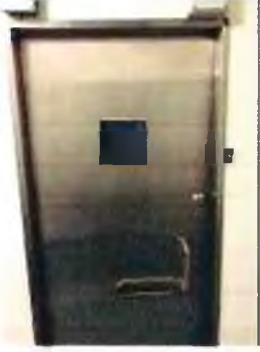
| 34 | G-20 | <p>The flat entrance door to property ■ does not appear to be fire resisting, see photograph below:</p> | <p>During the next maintenance works at the property, consideration should be given to replacing the entrance door to property ■ to ensure its compliance with British Standard 476.</p> <p>(It should be confirmed as non-fire resisting once opened and inspected).</p> | 4 | X | | | |

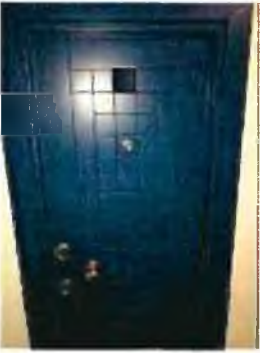
| 35 | G-20 | <p>The flat entrance door to property ■ does not appear to be fire resisting, see photograph below:</p> | <p>During the next maintenance works at the property, consideration should be given to replacing the entrance door to property ■ to ensure its compliance with British Standard 476.</p> <p>(It should be confirmed as non-fire resisting once opened and inspected).</p> | 4 | X | | | |

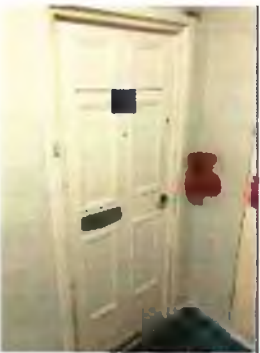
| 36 | G-20 | <p>The flat entrance door to property ■ does not appear to be fire resisting, see photograph below:</p> | <p>During the next maintenance works at the property, consideration should be given to replacing the entrance door to property ■ to ensure its compliance with British Standard 476.</p> <p>(It should be confirmed as non-fire resisting once opened and inspected).</p> | 4 | X | | | |

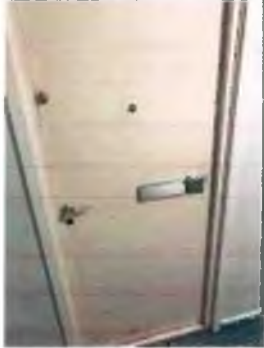
| 37 | G-20 | <p>The flat entrance door to property ■ does not appear to be fire resisting, see photograph below:</p> | <p>During the next maintenance works at the property, consideration should be given to replacing the entrance door to property ■ to ensure its compliance with British Standard 476.</p> <p>(It should be confirmed as non-fire resisting once opened and inspected).</p> | 4 | X | | | |

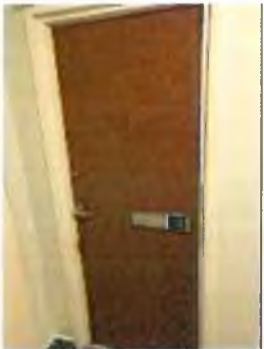
| 38 | G-20 | <p>The flat entrance door to property ■ does not appear to be fire resisting, see photograph below:</p> | <p>During the next maintenance works at the property, consideration should be given to replacing the entrance door to property ■ to ensure its compliance with British Standard 476.</p> <p>(It should be confirmed as non-fire resisting once opened and inspected).</p> | 4 | X | | | |

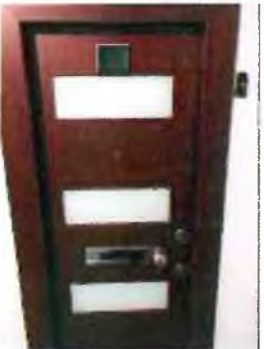
| 40 | G-20 | <p>The flat entrance door and glazing to property ■ does not appear to be fire resisting. See photograph below.</p> | <p>During the next maintenance works at the property, consideration should be given to replacing the entrance door and glazing to property ■ to ensure its compliance with British Standard 476.</p> <p>(It should be confirmed as non-fire resisting once opened and inspected).</p> | 4 | X | | | |
