FIRE RISK ASSESSMENT

Berkeley House

Premises Address: Berkeley House Wellington Way London, E3 4NG	Use of Premises: Residential block.
Date of Risk Assessment: 14 March 2017	Date of Review: 14 March 2018

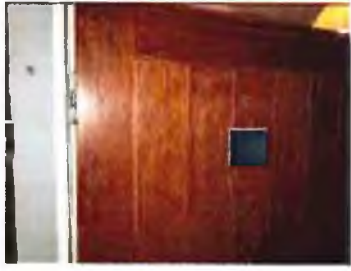
Item number	Floor	Remedial Works	Actions	Priority/tested and satisfactory/not applicable	Housing Centre	Asset Management	Date Rectified
1	G-21	<p>The flat entrance door to property ■ was inspected during the assessment and the following observation noted:</p> <p>It does not appear to be a compliant fire door. See photograph below:</p>

<p>(DOOR INSPECTED)</p>	<p>During the next maintenance works at the property, consideration should be given to replacing the entrance door to property ■ to ensure its compliance with British Standard 476.</p>	4	X		
2	G-21	<p>The flat entrance door to property ■ was inspected during the assessment and the following observation noted:</p> <p>It is a compliant fire door but has no self-closing device. See photograph below.</p>	<p>During the next maintenance works at the property, consideration should be given to adding a self-closing device to property ■ to ensure its compliance with British Standard 476.</p>	4	X

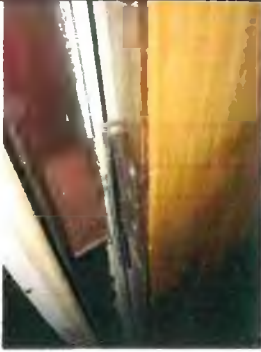
<i>(DOOR INSPECTED)</i>						
3	21	<p>The flat entrance door to property ■ was inspected during the assessment and the following observation noted:</p> <p>It does not appear to be a compliant fire door. See photograph below:</p>

<p>During the next maintenance works at the property, consideration should be given to replacing the entrance door to property ■ to ensure its compliance with British Standard 476.</p>	4	X			
		<i>(DOOR INSPECTED)</i>						
4	G-21	<p>The flat entrance door to property ■ was inspected during the assessment and the following observation noted:</p> <p>It is a compliant fire door but has no self-closing device. See photograph below.</p>

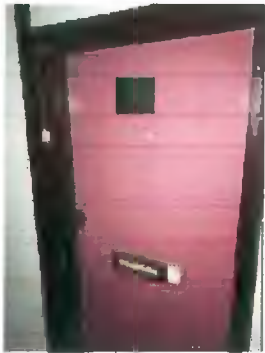
8	G-21	<p>The flat entrance door to property ■ does not appear to be the original fire door and could not be confirmed as fire resisting, see photograph below:</p>	<p>During the next maintenance works at the property, consideration should be given to replacing the entrance door to property ■</p>	4

<p><i>to ensure its compliance with British Standard 476.</i></p> <p><i>(It should be confirmed as non-fire resisting once opened and inspected).</i></p>		X			
9	G-21	<p>The flat entrance door to property ■ does not appear to be the original fire door and could not be confirmed as fire resisting, see photograph below:</p>

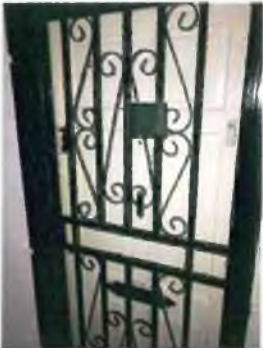
<p><i>During the next maintenance works at the property, consideration should be given to replacing the entrance door to property ■ to ensure its compliance with British Standard 476.</i></p> <p><i>(It should be confirmed as non-fire resisting once opened and inspected).</i></p>	4	X			
10	G-21	<p>The flat entrance door to property ■ does not appear to be the original fire door and could not be confirmed as fire resisting, see photograph below:</p>

<p><i>During the next maintenance works at the property, consideration should be given to replacing the entrance door to property ■ to ensure its compliance with British Standard 476.</i></p> <p><i>(It should be confirmed as non-fire resisting once opened and inspected).</i></p>	4	X

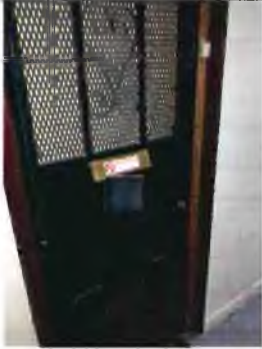
11	G-21	<p>The flat entrance door to property ■ does not appear to be the original fire door and could not be confirmed as fire resisting, see photograph below:</p>	<p><i>During the next maintenance works at the property, consideration should be given to replacing the entrance door to property ■ to ensure its compliance with British Standard 476.</i></p> <p><i>(It should be confirmed as non-fire resisting once</i></p>	4	X

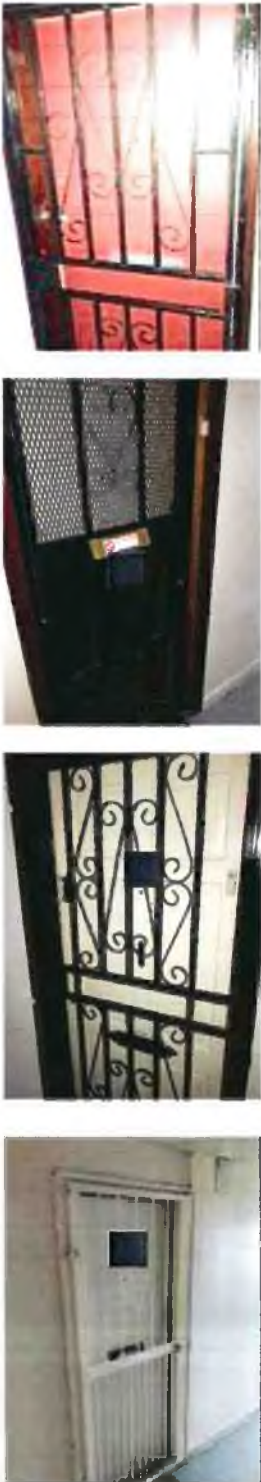
<p>Residents should be advised to keep the common areas, staircases and areas outside their flats clear, sterile and unobstructed at all times. These fire escape routes must be protected at all times. This also includes around the perimeter of the building to reduce the chances of an arson attack.</p>	1	X			
16	G-21	<p>Security gates have been installed to flats [redacted] [redacted] [redacted] [redacted] and [redacted]. For</p>	<p>Eastend homes should continue with the policy of informing their tenants about</p>	3	X

<p><i>example, see photographs below.</i></p>

<p><i>the use and safety of security gates.</i></p>					
17	G-21	<p><i>There are scorched signs throughout the property, see photographs below.</i></p>	<p><i>Residents should be warned about the dangers of arson and this situation monitored.</i></p>	3	X
