FIRE RISK ASSESSMENT

Ennerdale House

Premises Address: <i>Ennerdale House Hamlets Way London, E3 4TU</i>	Use of Premises: <i>Residential block.</i>
Date of Risk Assessment: <i>20 February 2017</i>	Date of Review: <i>20 February 2018</i>

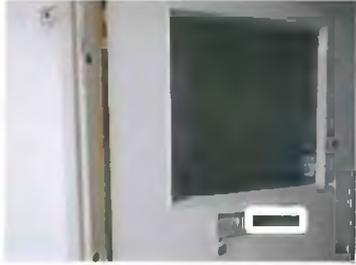
Priority/tested and satisfactory/not applicable	Housing Centre	Asset Management		Date Rectified
Item number	Floor	Remedial Works	Actions					
1	2	<p>The flat entrance door to property ■ was inspected during the assessment and the following observation noted:</p> <p>It is a compliant fire door but is not fitted with a self-closer, intumescent strips and smoke seals. See photograph below.</p>

<p>(DOOR INSPECTED)</p>	<p>During the next maintenance works at the property, consideration should be given to adding a self-closer, intumescent strips and smoke seals to the front entrance door to property ■ to ensure its compliance with British Standard 476.</p>	4	X			
2	4	<p>The flat entrance door to property ■ was inspected during the assessment and the following observation noted:</p> <p>It does not appear to be a compliant fire door with fire resisting glazing. See photograph below.</p>	<p>During the next maintenance works at the property, consideration should be given to replacing the door and glazing to property ■ to ensure its compliance with British Standard 476.</p>	4	X

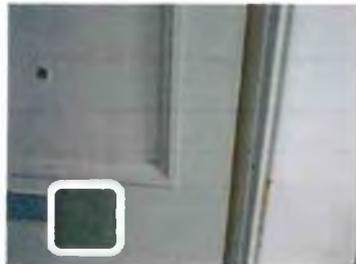
5	10	<p>The flat entrance door to property ■ was inspected during the assessment and the following observation noted:</p> <p>It is a compliant fire door but is not fitted with a self-closer, intumescent strips and smoke seals. See photograph below.</p>

<p>(DOOR INSPECTED)</p>	<p>During the next maintenance works at the property, consideration should be given to adding a self-closer, intumescent strips and smoke seals to the front entrance door to property ■ to ensure its compliance with British Standard 476.</p>	4	X				
6	13	<p>The flat entrance door to property ■ was inspected during the assessment and the following observation noted:</p> <p>It is a compliant fire door but is not fitted with a self-closer, intumescent strips and smoke seals. See photograph below.</p>

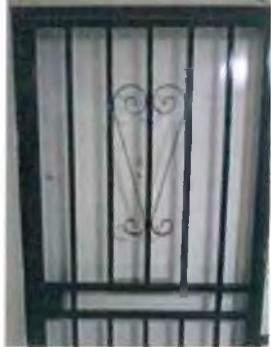
7	1	<p>The flat entrance door to property ■ does not appear to be fire resisting, see photograph below:</p>

<p>During the next maintenance works at the property, consideration should be given to replacing the entrance door to property ■ to ensure its compliance with British Standard 476.</p> <p>(It should be confirmed as non-fire resisting once opened and inspected).</p>	4	X

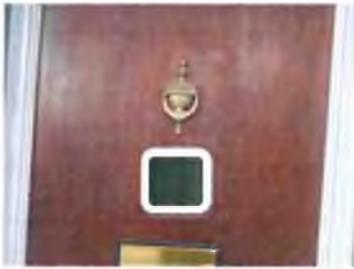
8	3	<p>The flat entrance door to property ■ does not appear to be fire resisting, see photograph below:</p>

<p>During the next maintenance works at the property, consideration should be given to replacing the entrance door to property ■ to ensure its compliance with British Standard 476.</p> <p>(It should be confirmed as non-fire resisting once opened and inspected).</p>	4	X			
9	3	<p>The flat entrance door to property ■ does not appear to be fire resisting, see photograph below:</p>

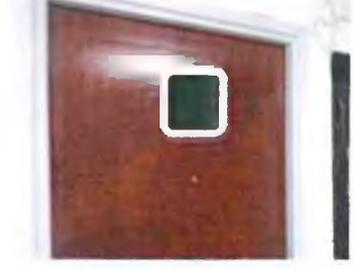
<p>During the next maintenance works at the property, consideration should be given to replacing the entrance door to property ■ to ensure its compliance with British Standard 476.</p> <p>(It should be confirmed as non-fire resisting once opened and inspected).</p>	4	X			
10	5	<p>The flat entrance door to property ■ does not appear to be fire resisting, see photograph below:</p>

<p>During the next maintenance works at the property, consideration should be given to replacing the entrance door to property ■ to ensure its compliance with British Standard 476.</p> <p>(It should be confirmed as non-fire resisting once opened and inspected).</p>	4	X

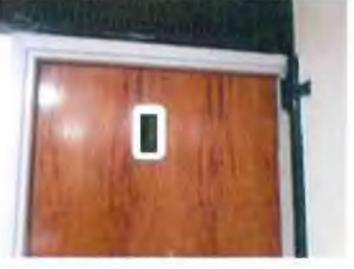
11	5	<p>The flat entrance door to property ■ does not appear to be fire resisting, see photograph below:</p>

<p>During the next maintenance works at the property, consideration should be given to replacing the entrance door to property ■ to ensure its compliance with British Standard 476.</p> <p>(It should be confirmed as non-fire resisting once opened and inspected).</p>	4	X

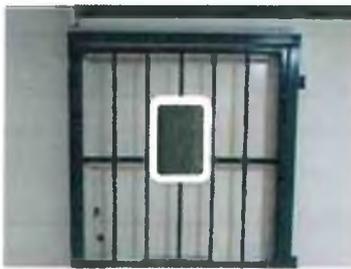
12	12	<p>The flat entrance door to property ■ does not appear to be fire resisting, see photograph below:</p>

<p>During the next maintenance works at the property, consideration should be given to replacing the entrance door to property ■ to ensure its compliance with British Standard 476.</p> <p>(It should be confirmed as non-fire resisting once opened and inspected).</p>	4	X				
13	13	<p>The flat entrance door to property ■ does not appear to be fire resisting. See photograph below:</p>

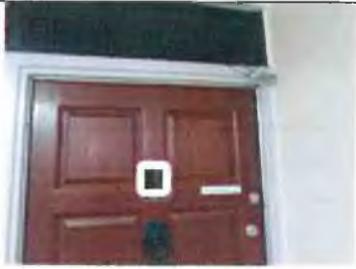
15	4	<p>The flat entrance door to property ■ does not appear to be fire resisting, see photograph below:</p>	<p>During the next maintenance works at the property, consideration should be given to replacing the entrance door to property ■ to ensure its compliance with British Standard 476.</p> <p>(It should be confirmed as non-fire resisting once opened and inspected).</p>	4	X

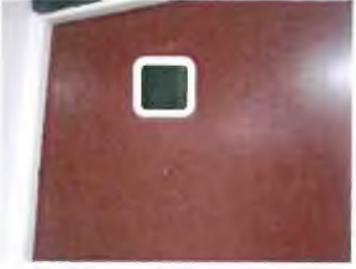
16	11	<p>The flat entrance door to property ■ does not appear to be fire resisting, see photograph below:</p>

<p>During the next maintenance works at the property, consideration should be given to replacing the entrance door to property ■ to ensure its compliance with British Standard 476.</p> <p>(It should be confirmed as non-fire resisting once opened and inspected).</p>	4	X			
17	17	<p>The flat entrance door to property ■ does not appear to be fire resisting, see photograph below:</p>

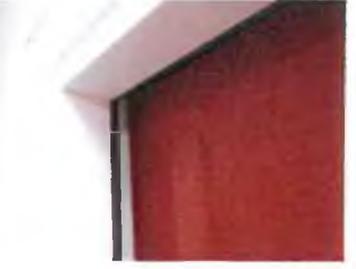
<p>During the next maintenance works at the property, consideration should be given to replacing the entrance door to property ■ to ensure its compliance with British Standard 476.</p> <p>(It should be confirmed as non-fire resisting once opened and inspected).</p>	4	X			
18	9	<p>The flat lobby fire door on the 9th floor does not shut tightly into its frame. See photograph below.</p>

<p>This fire door should shut tightly into its frame and should be repaired as necessary.</p>	4	X

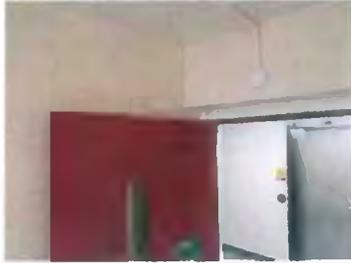
19	17	<p>The self-closing device to the flat lobby fire door on the 17th floor is broken. See photograph below.</p>

<p>This self-closing device should be repaired to ensure this fire door shuts tightly into its frame.</p>	3	X			
20	G-18	<p>The following issues were noted:</p> <p>There were bags, boxes and plants on the 3rd, 10th, 13th and 15th floors. See photographs below.</p>

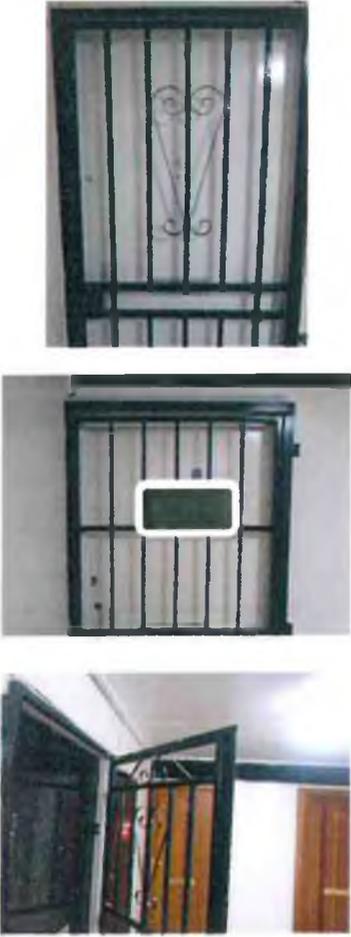
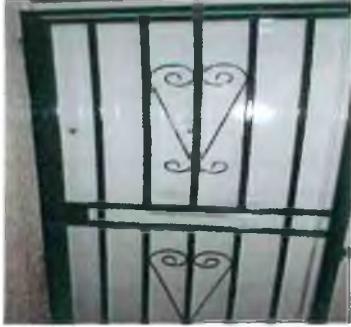
21	G-18	<p>Security gates have been installed to flats [redacted] and [redacted]. See photographs below.</p>

<p><i>Eastend homes should continue with the policy of informing their tenants about the use and safety of security gates.</i></p>	3	X

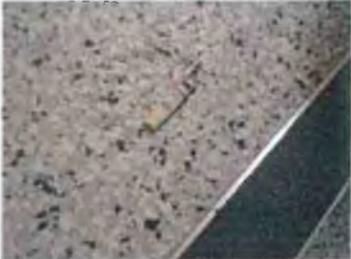
22	G-18	<p>It was noted that smoking takes place in the following areas;</p> <ul style="list-style-type: none"> Along the staircase <p>See photographs below.</p>

<p>Residents must never smoke within any common parts of the building or within close proximity to the building. These cigarette ends/packs/ashtrays should be discarded off immediately.</p>	1	X
